AVK ENCAPSULATION COLLARS

**ENCAPSULATION COLLARS
FOR UNDER-PRESSURE
PIPE REPAIR**

ENCAPSULATION COLLARS UNDER-PRESSURE REPAIR OF PIPE SOCKETS AND WALLS

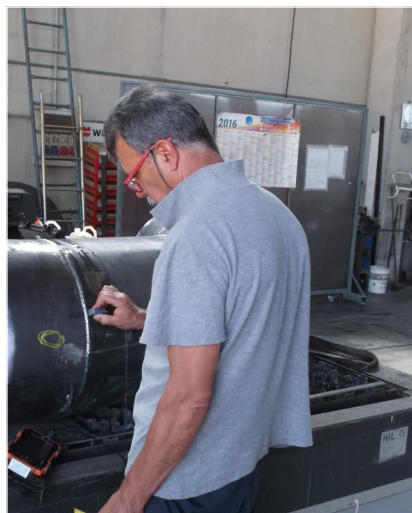
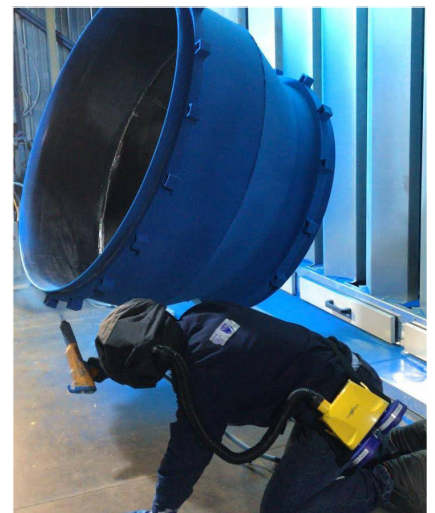
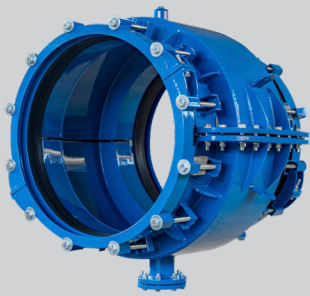
The standard encapsulation collars are made of fabricated carbon steel with fusion bonded epoxy coating, and the coating as well as the rubber seals in contact with water are WRAS approved.

They are designed with flange outlet suitable for hot tapping and drainage of water, and air vent for the release of air as the last step of the installation. Lifting eyes are integrated in the reinforcing plates.

In addition to the substantial standard range of up to DN2000, the collars can be delivered with stainless steel body and/or stainless steel fasteners, for higher pressure ratings, up to DN3000, and even in a customised design.

Hydro Stop series 8001/0, PN16
Socket encapsulation collar, DN250-2000

Hydro Stop series 8001/2
Pipe encapsulation collar, DN300-2000

Hydro Fast series 8002/0
Socket encapsulation collar, DN300-2000

Hydro Fast series 8002/2
Pipe encapsulation collar, DN300-2000

Hydro Smart series 8003/0
Socket encapsulation collar, DN80-250

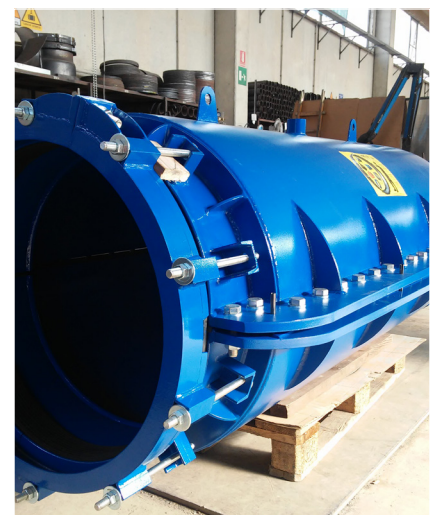
Hydro Fast encapsulation collars have a tolerance of up to 10 mm on the outside pipe diameter and are dedicated to a specific pipe material. Variants are available for all pipe materials and for both pipe socket repair and pipe wall repair.

- Hydro Fast **socket** encapsulation collars with shaped body accommodate and seal pipe sockets connecting two pipes of the same material.
- Hydro Fast **pipe** encapsulation collars with straight body accommodate and seal slightly misaligned breaks on pipe walls.

The lightweight compact design is ideal for fragile pipes and limited space on site, and they allow for angular deflection of up to $\pm 6^\circ$ before or after installation offering great flexibility.

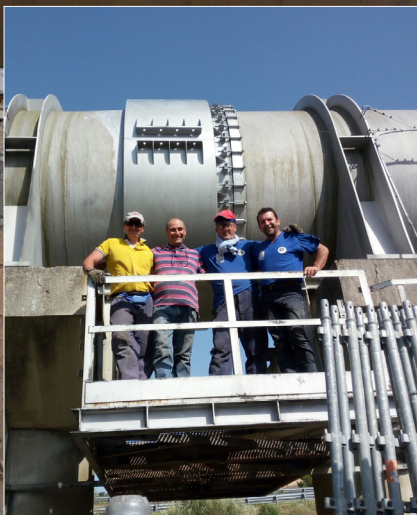
In 2017, E.I.P.L.I. planned the repair of several leaks on the largest and most important pipeline in southern Italy: Adduttore Sinni. It is a DN3000 steel pipeline that supplies fresh water to Apulia and Lucania, serving about 4.5 million people. It goes from the Sinni dam to the western area of the Taranto district covering a distance of about 133 km.

Basically, the DN3000 flanges that connected the pipes, as well as the expansion joints, were worn out and had started to leak severely. Considering the large population potentially involved in disruption of water supplies, the only possible way to perform any repair was by using our Hydro Stop socket encapsulation collar.

For the eight big leaks, we designed eight different variants of Hydro Stop collars, capable of working not only as encapsulation and repair collars, but also as expansion joints: we offered a product capable of fulfilling two different purposes.

Often, we had to face severe conditions during installation. The most challenging installation was performed in the Montescaglioso district, where the pipeline crossed hillside. This special circumstance caused a pressure increase from the average of 10 to 16 bar up to a peak of 24 bar; a very high pressure for such a large pipeline! Stopping this leak was a real challenge, and we therefore decided to oversize the collar to ensure the highest possible reliability over time.

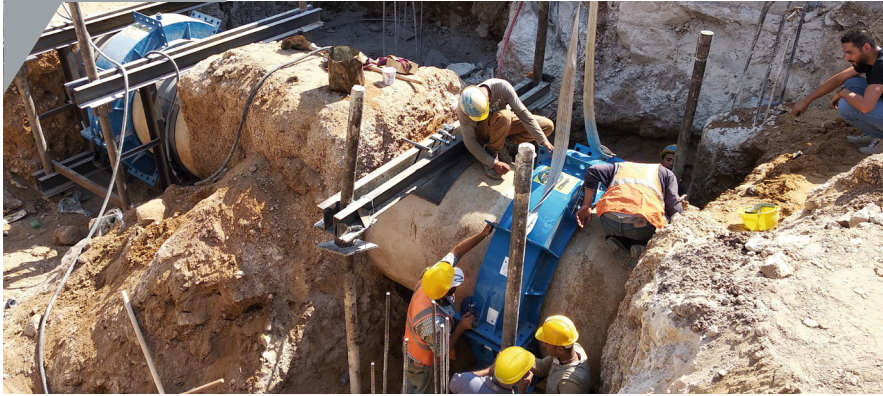
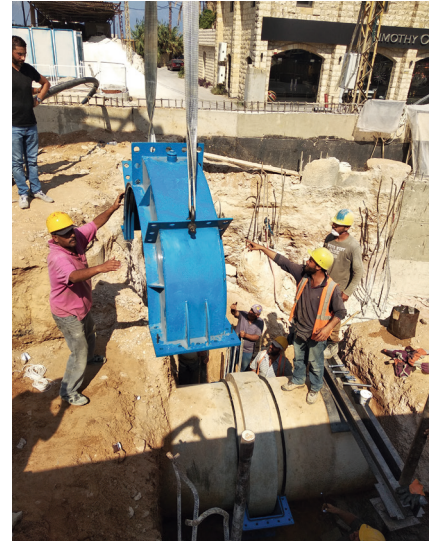
Hydro Fast socket encapsulation collars used to protect two socket joints on a concrete pipe in Beirut City in Lebanon.

This pipeline crosses the new Jal ed dib overpass, and the pillars of the new flyover were to be built next to the joints, so it was necessary to protect them from possible damage caused by the construction of the pillars. In fact, Beirut Water Authority wanted encapsulation collars for preventive repair of the socket joints.

Because of lack of space on site, a solution with a very short overall length was needed, since the maximum length was restricted to 600 mm. Therefore, we offered our Hydro Fast socket encapsulation collars, as they have no flanges, and the overall length could therefore be reduced to 530 mm.

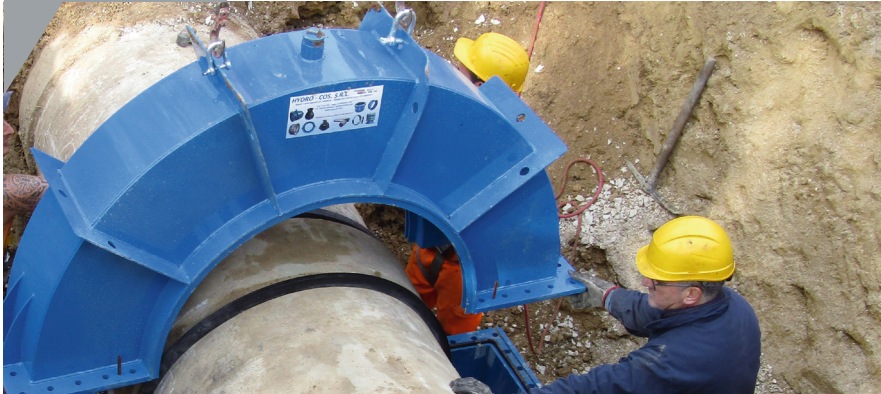
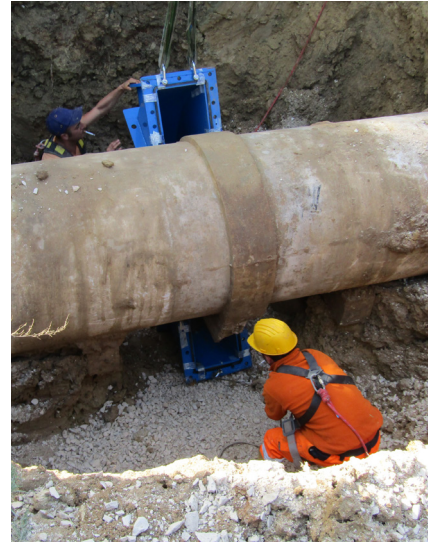
Hydro Fast socket encapsulation collar used for repairing a leaking socket joint on old and fragile concrete pipeline located in Puglia in southern Italy.

The pipe was very old, and some cracks had appeared on its anchor blocks. The anchor blocks were moulded directly on the pipe, so water leaked from the cracks as if it leaked directly from the pipe wall itself.

We had a situation with two problems; the leak itself and a slow collapse of the pipeline because of continuous enlarging of the cracks on the anchor blocks. Two fitters from Hydro-Cos went to the site to study the situation and take measurements. On the upper part, the concrete joint was only 25 mm high, while on the lower part, the height of the joint including the anchor block exceeded 300 mm.

Considering the fragility of the pipe caused by the serious damage to the anchor block, we proposed our Hydro Fast socket encapsulation collar. Because of its light-weight design it would only cause a minimum amount of stress on the damaged pipe anchor. In order to reduce the vertical extension of the collar, we manufactured a DN100 lower flange spigot in the form of a mouth-of-a flute intersection.

After installation, it was only necessary to place two small support devices under the pipe on each side of the concrete joint, to replace the anchor block now encapsulated in the Hydro Fast collar.
